Subject: **Annual Inspection Report**
Grove Hill Municipal Airport

ANNUAL INSPECTION REPORT

GROVE HILL MUNICIPAL AIRPORT

GROVE HILL, ALABAMA

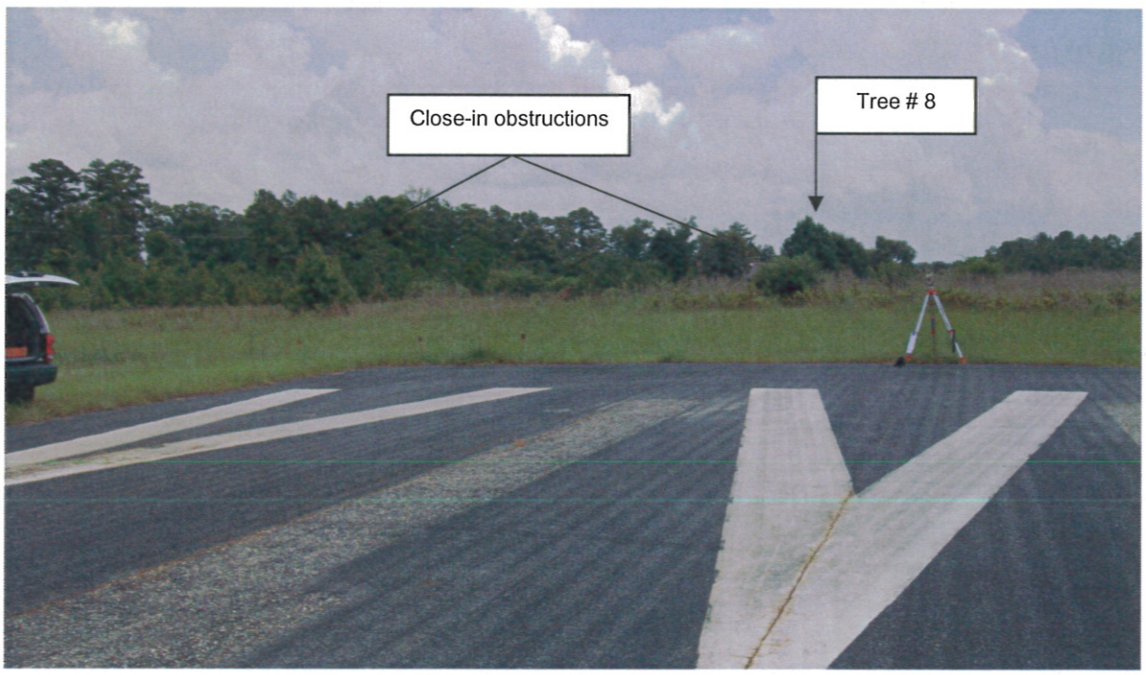
Photo # 2 - Runway 31 Obstructions

- Runway 31 - The approach/departure path is obstructed by numerous close-in obstructions as well as a tree identified as Tree # 8 (See Photo # 2, # 3 and Appendix 2).

- All obstructions to the ALDOT 20:1 approach/departure path must be removed

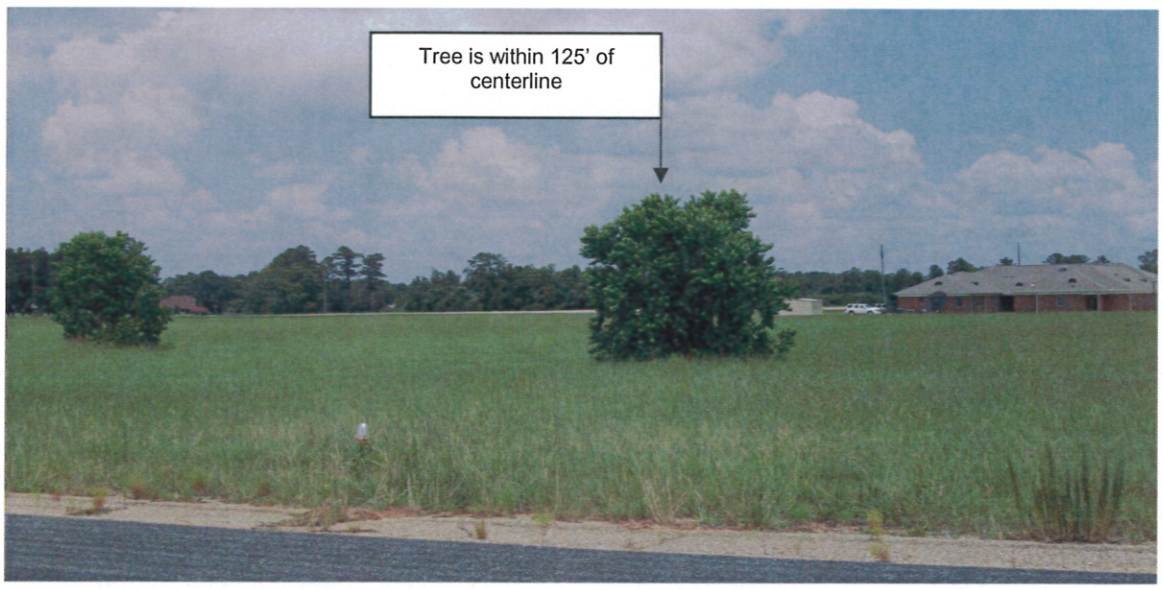
Photo # 4 – Primary Surface Violation

- The primary surface is violated by a small tree, located on the north side of the runway (See Photo # 4).

- Obstruction to primary surface must be removed.

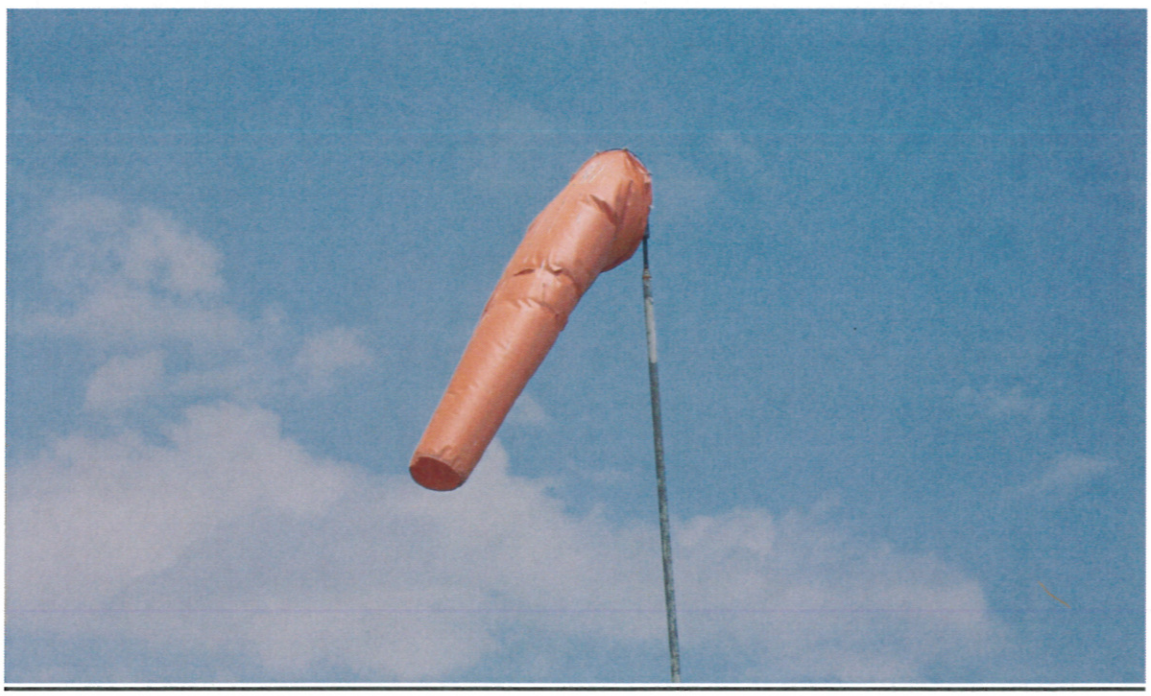
Photo # 6 – Wind Cone

- The wind direction indicator complies with state licensing standards (See Photo # 6).
